DEPARTMENT OF TRANSPORTATION**DIVISION OF ENGINEERING SERVICES**

Contract #: 04-0120F4Cty: SF/ALA Rte: 80 PM: 13.2/13.9File #: 69.15**SOURCE INSPECTION REPORT****Resident Engineer:**Pursell, Gary**Address:** 333 Burma Road**City:** Oakland, CA 94607**Report No:** SIR-000652**Date Inspected:** 16-May-2009**Project Name:** SAS Superstructure**OSM Arrival Time:** 0**Prime Contractor:** American Bridge/Fluor Enterprises, a JV**OSM Departure Time:** 12**Contractor:** Zhenhua Port Machinery Company, Ltd (ZPMC), Changxing Island **Location:** Changxing Dao, Shanghai

Other: Surface Preparation and Coatings Application**Bridge No:** 34-0006**Component:** OBG 1AE, Lift 3&4, Misc. Metal, Tower L1E**Bid Item:** 77,78,79,80**Lot No:** B226**Summary of Items Observed:**

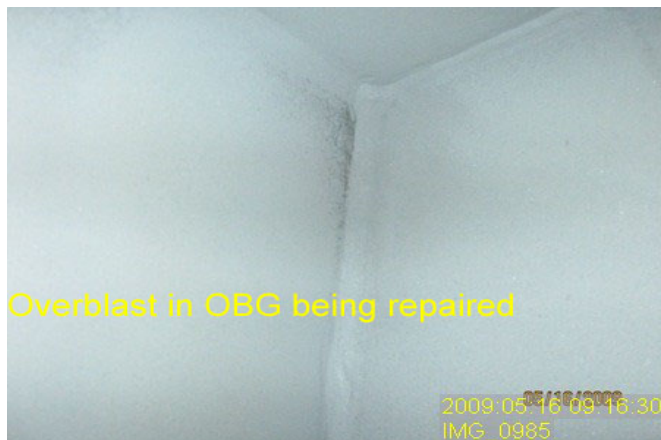
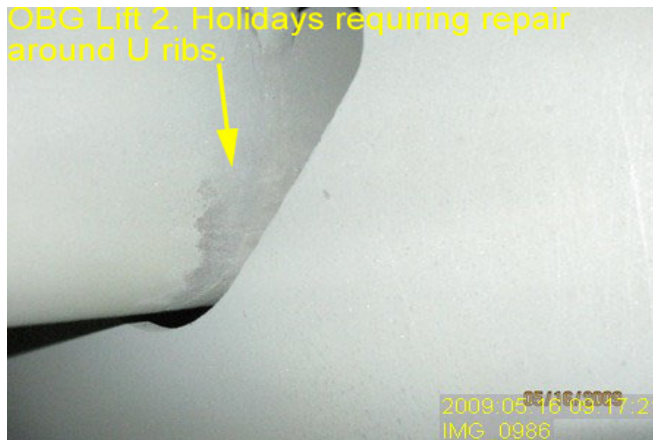
Caltrans QA Coatings Inspectors received a Notice of Inspection for to attend a joint inspection with ABF and ZPMC QC to locate visual surface anomalies and weld defects on the floor area of OBG 2AW. ABF verbally requested that the Caltrans welding staff be notified to perform VT inspection after blast. Areas requiring grinding were identified and marked by QC and QA staff. Caltrans QA Weld Inspector's performed VT inspection to locate and mark any weld repairs required. The weld repair spots were identified by placing tape over the area so it can be located after primer application. After the inspection was complete, grinding was performed to remove base metal defects. Abrasive blasting resumed after grinding was completed. NO ZPMC or ABF steel inspectors were on site looking at the welds.

Fabrication on assembled components of the OBG's are not complete. Coating damage requiring re-blast is expected.
